coou African Journal of Environmental Research Vol 2, No. 1, 2019. pp 66-75

## Appraisal Of Building Conditions In Public Secondary Schools In Onitsha, Nigeria

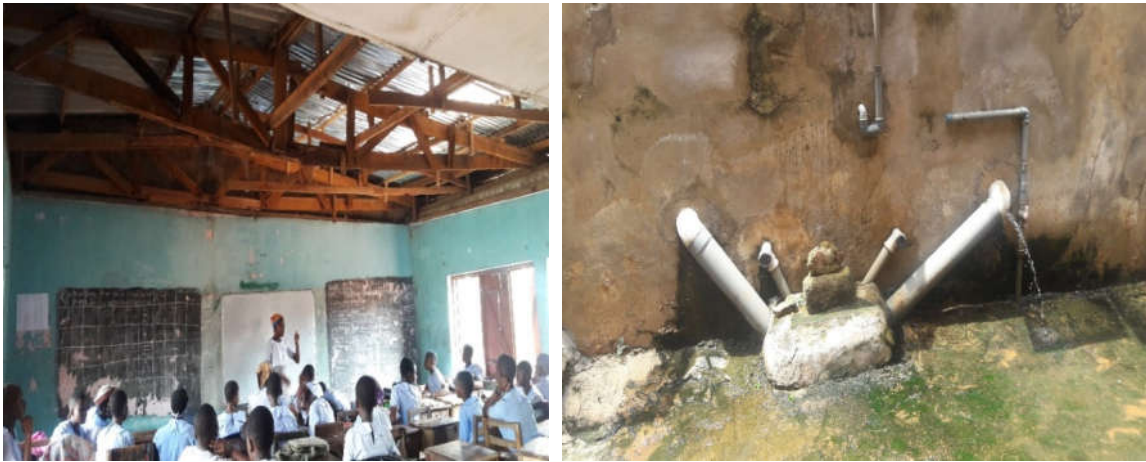
Plate 1: Showing classroom without ceiling boards and dilapidated sanitary fittings in a school building

With regard to the conditions of each of the seven building elements investigated, it is evident from the results of the analysis that the condition of floors, wall finishes, doors/windows, stairs and sanitary fittings were rated 'poor' following some notable amount of damages on those elements such as pronounced peelings on the floors and walls, structural cracks, efflorescence, discolorations, broken louver blades, leaking and broken sanitary pipes and rusted rails. However, the roof members and electrical fittings were found to be in moderate condition. The result implies that majority of the building elements in the schools were in deplorable condition requiring either minor or major repairs. The results are illustrated in Table 2, Plate 1 and Plate 2.

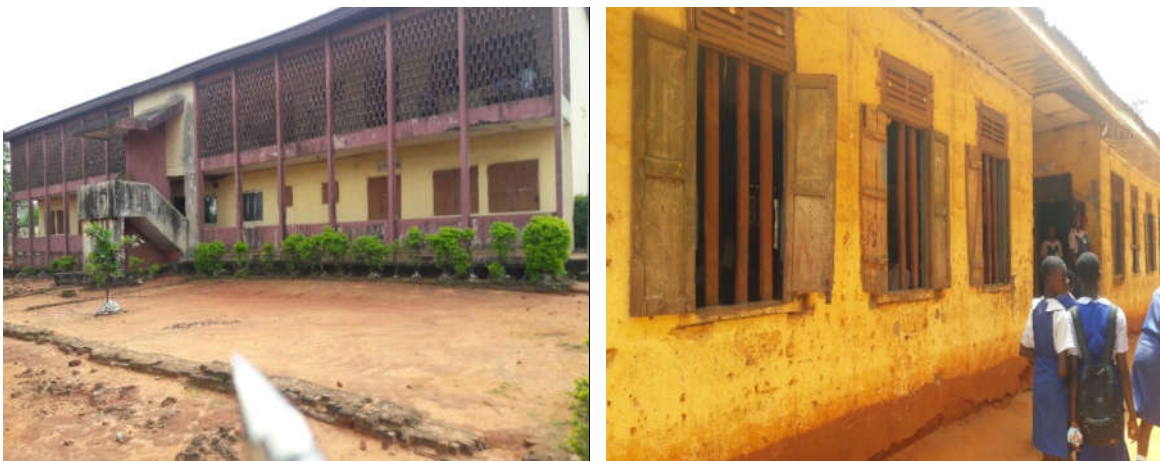
Plate 2: Showing dilapidated classroom blocks in the schools in the study area.
