COMMUNITY MONSTER: RECLAIMING THE BORROW PITS IN BATAGARAWA COMMUNITY OF NORTH-WESTERN NIGERIA

Gidado, Usman Muhammad¹, Jokolo, Maryam Al-Mustapha² & Saleh-Bala, Maimuna³

^{1, 2, & 3} Department of Architecture, Ahmadu Bello University, Zaria

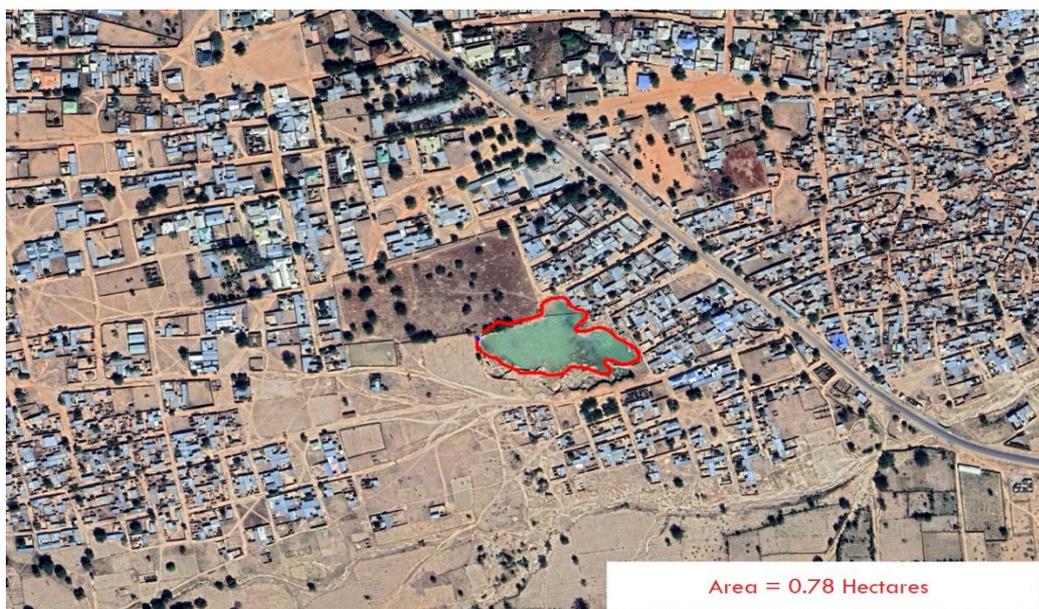
Figure 1: Google Image showing the borrow pit containing water within Batagarawa township

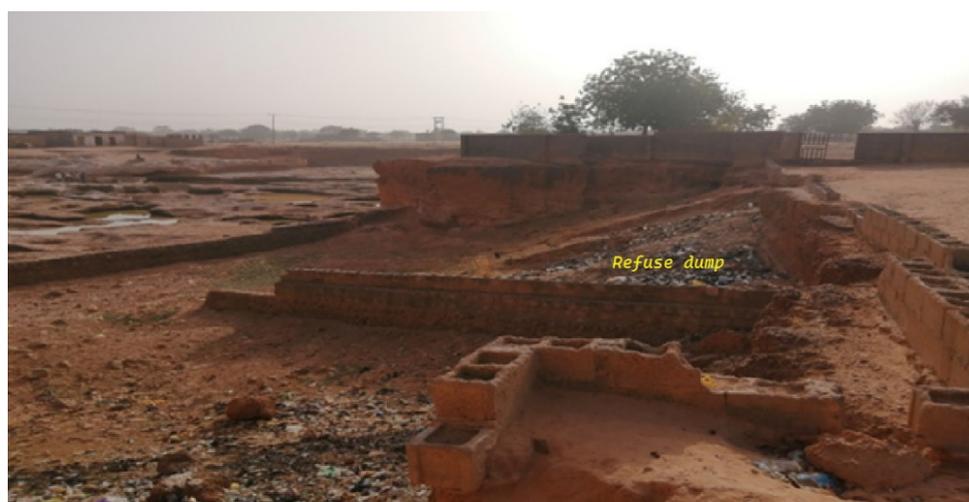
When the excavation began in the 1970s, the site was approximately one kilometre away from the settlement. As a result of extensive excavation activities due to population growth and increased shelter demand, the pit now covers a large area, and is almost merging with the settlement area. It is also encroaching on some important sites on the outer fringes of Batagarawa town, for example, the Muslims' annual congregational prayer site (Eid ground) and its environs. Equally, the perimeter walls of the community's graveyard's are almost on the pit. Also, because the pit has expanded to reach the perimeter fences of some buildings, it has been turned into sewage and refuse dump site, as shown in Plate 1.

Plate 1: Showing the borrow pit encroachment on the perimeter wall of community graveyard, as well as waste dump sites within it

The pit keeps getting bigger and deeper as the demand for clay as a building material increases. The ditches have now come together to form an enormous borrow pit, with excavation occurring at various points along the pit to deepen those points. This has created a monster in the community, as depicted in Plate 1, with an estimated area of 68,400 square meters and depths ranging from 0.7 meters to 6 meters, all formed into an irregular shape. The pit is active because excavation activities are continuing, and this has caused it to expand to the point where it now approaches the nearby land uses. There are narrow pathways in the

First, the State Government and the Local Government Authority should work together to establish a supervisory and regulatory framework for controlling excavation activities in the entire district, so that those that breach the rule will be prosecuted. Second, the two tiers of government mentioned need to mobilize the excavators into a cooperative for ease of regulation and control. Third, the government should encourage the cooperative to organize the installation of safety handrails in appropriate sections of the pathways. Fourth, the appropriate state ministry should liaise with the Local Government Area and the Cooperatives to pave necessary sections of the important paths while closing the less important ones. Fifth, the State Government should liaise with the Federal Government to provide sustainable water infrastructure to the community; and sixth, the three tiers of government should work together to reclaim and turn the abandoned portions of the borrow pits into agricultural land for organized farm business.

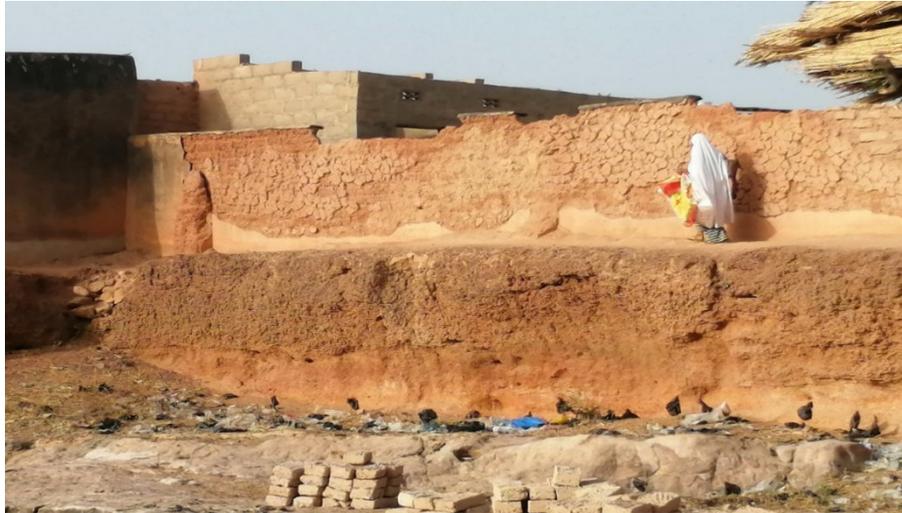
east and north of Batagarawa linking the community, and walking on these pathways could be dangerous, particularly for the children. With no safety barrier, the locals made a path for their waste dumping, as shown in Plate 2 and Plate 3. This shows that both adults and children pass through this dangerous narrow slippery path on the cliff of an unprotected raven to get to different parts of the community.

Plate 2: A woman walking on the narrow footpath which borders the borrow pits and the buildings with no protective barrier

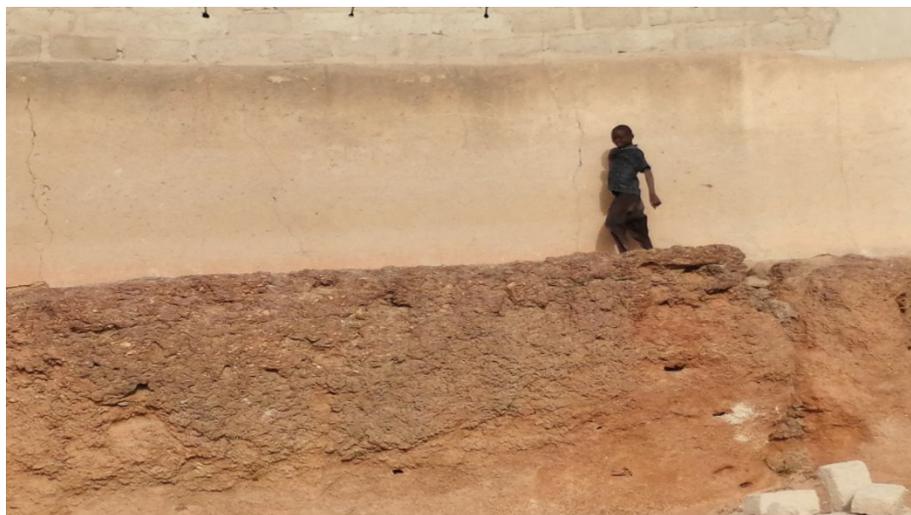
Plate 3: A boy walking on the narrow footpath which borders the borrow pit and the buildings with no protective barrier

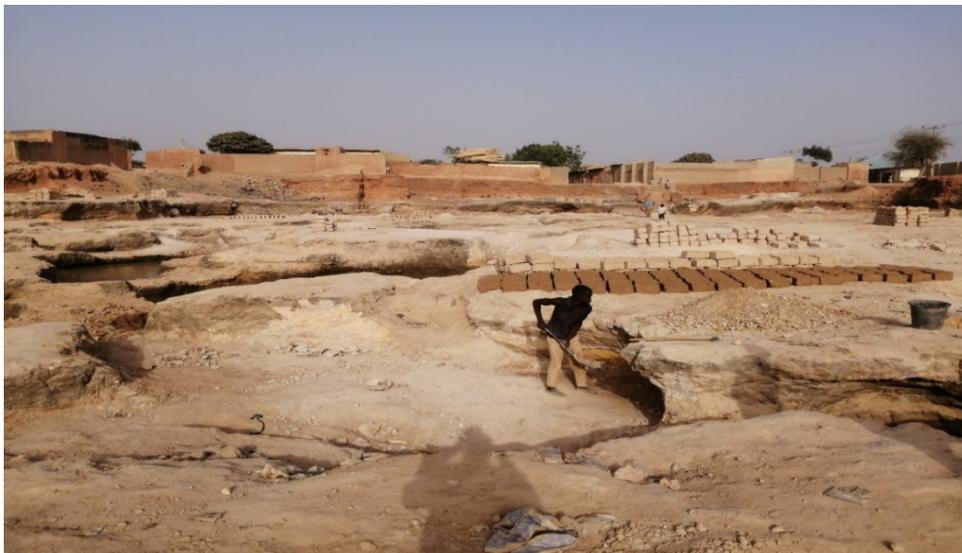
Since the 1970s, residents of the study area have been using the borrow pit sites to extract clay or laterite for use as building materials. Plate 4 shows that the borrow pit is still in use, with people using the excavated clay to make blocks while utilizing the water that was stored in the lakes that were formed during the excavation. The community has used materials excavated up there to construct several buildings and has continued to use the rubble and soil dug up from the borrow pits. The best locations in the borrow pits to find clay is in the floodplains of rivers and streams as well as at the base of ponds, and lakes, this encourages the excavators to dig trenches within the pit forming a sort of man-made lake. They also use the lakes as sources of water supply in the mud block production process. Ponds of water are trapped in the excavated pits for various economic uses.

Plate 4: Shows how the community excavates the borrow pits to make the building materials.

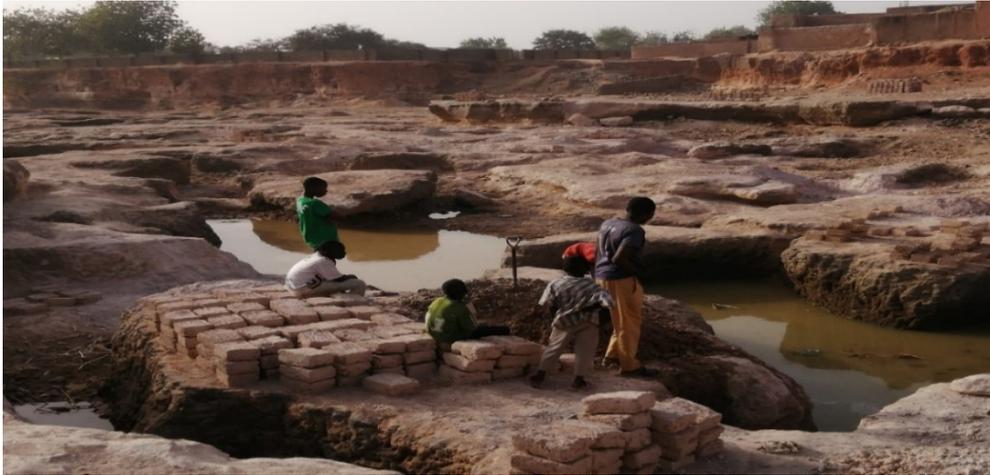
Plate 5 and Plate 6 illustrate that water in the lake serves dual purposes, for example, Plate 5 shows mud excavators using water from the artificial mini lakes for making mud blocks, while a woman and her child are depicted in Plate 6 sourcing water for household's domestic uses.

Plate 5: Showing how the borrow pits store water in the form of lakes which the excavators use to mould blocks

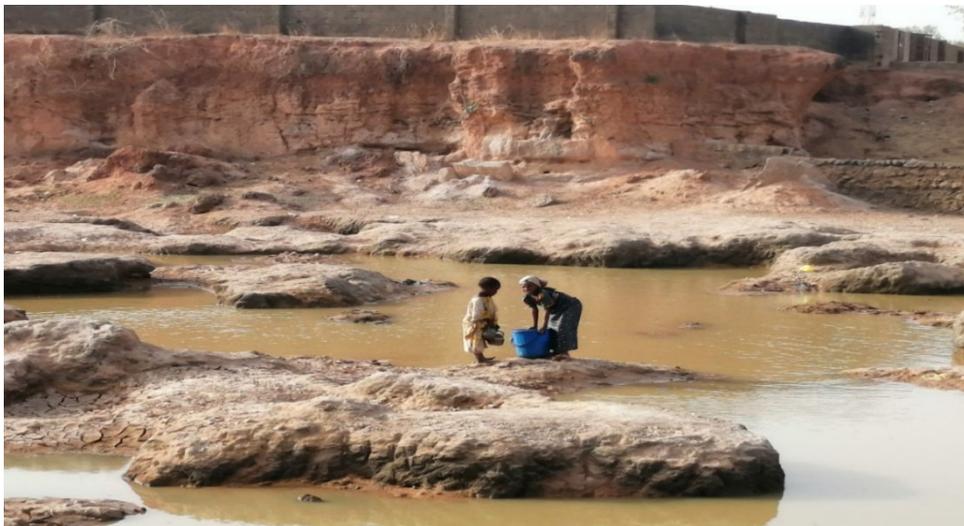
Plate 6: A woman and her child crossed all the hurdles to fetch water from one of the lakes within the borrow pits for domestic use

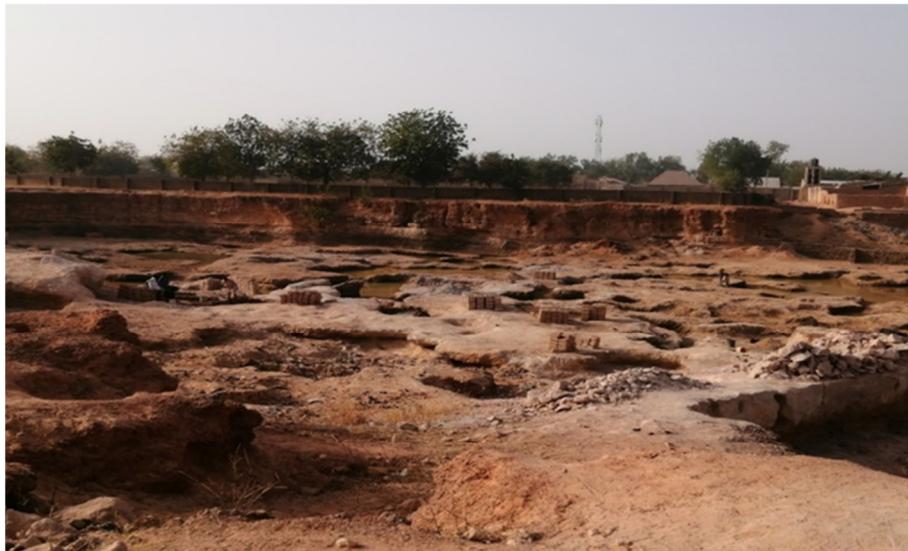
Therefore, the pit's negative effects cannot be overstated. Loss of life in the site has almost become routine, with an average of two people dying annually, particularly during the rainy season because the unprotected narrow walk paths around the pits become slippery during the rainy season. All of the participants agreed that deaths occur almost yearly and that the water accumulated in the pit is turbid and does not visibly appear suitable for drinking (as can be seen in Plate 6). Some of the adjacent buildings' perimeter fence walls have collapsed, while the fence walls of other nearby buildings to the pits other are about to collapse too. Regardless, of the severe threat to human residences, presently caused by the expansion of the borrow pit in the area, excavation is still on-going. Furthermore, excavation in the pit has reached the road on the southern side, thus, narrowing the access way on that axis too, and also increasing the danger to human life in the area. Although it has earlier been highlighted that the borrow pit is a major source of water for the community, the participants however confirmed that water from the pit is of very poor quality. The use of such poor-quality water could be harmful to human health and well-being. Plate 7 shows how the pit's environment has deteriorated.

Plate 7: The borrow pits and the extent of damage done to the environment
